**Region 9 Enforcement Division
75 Hawthorne Street
San Francisco, CA 94105
PHILLIPS 66 CARSON PHOTOGRAPH LOG**

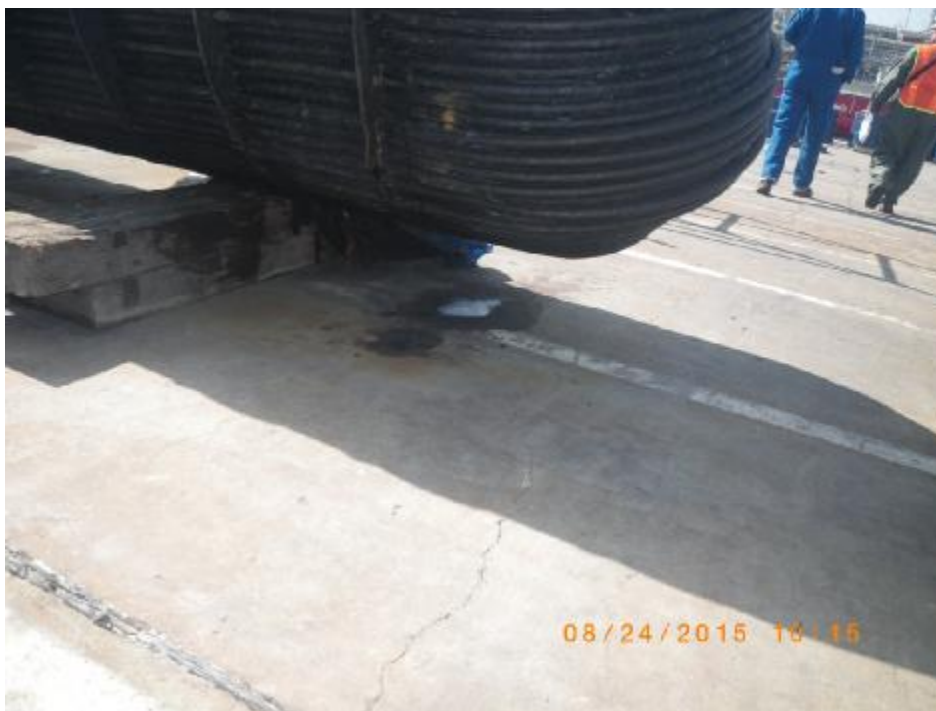
Photograph 1. IMGP0181.jpg –Oily staining beneath a heat exchange bundle at the temporary HEB cleaning pad, also referred to as the “Car Wash”.

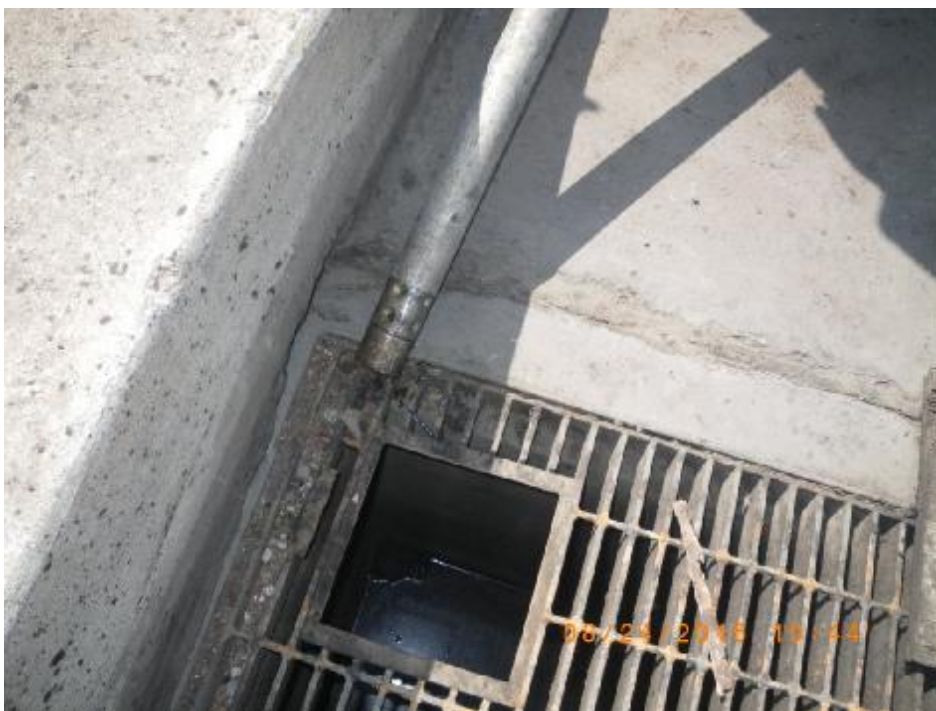
Photograph 2. IMGP0194.jpg – Accumulated liquids in the drainage sump at the Carson temporary HEB cleaning pad, also referred to as the “car wash.”

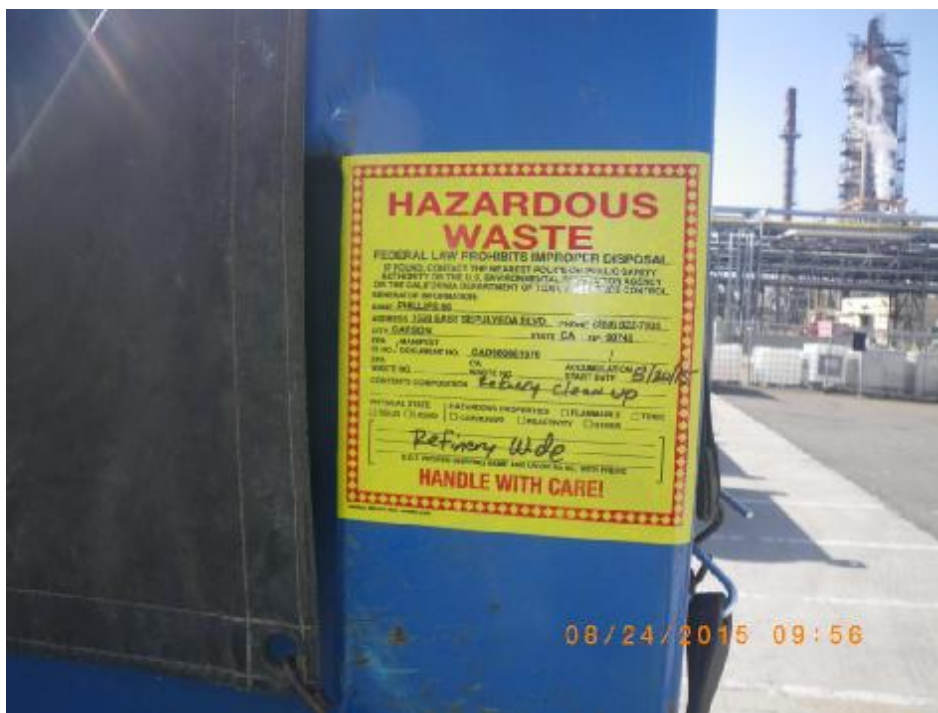
Photograph 3. IMGP0164.jpg – Roll-off container of hazardous waste at the Carson HWAA. The physical state and hazardous properties portion of the label were not filled out.

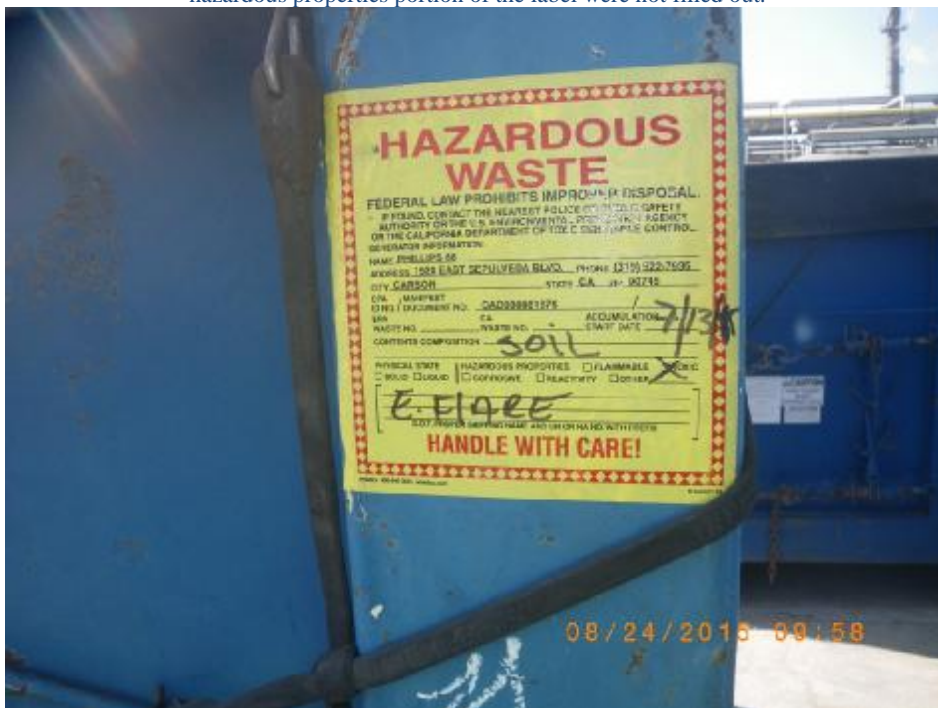
Photograph 4. IMGP0165.jpg – A second roll-off container of hazardous waste at the Carson HWAA. The physical state portion of the label was not filled out.

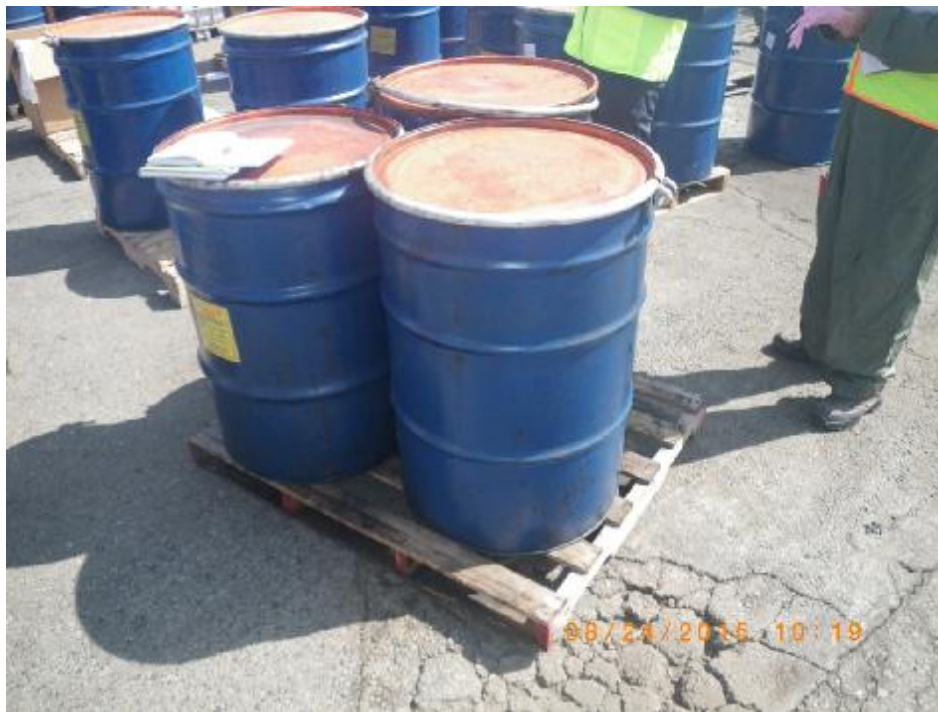
Photograph 5. IMG0186.jpg – One of these three containers was labeled “Sludge from FR 4,5,6 from Flasher”. The other two containers were unlabeled. One of the containers was not bolted shut.

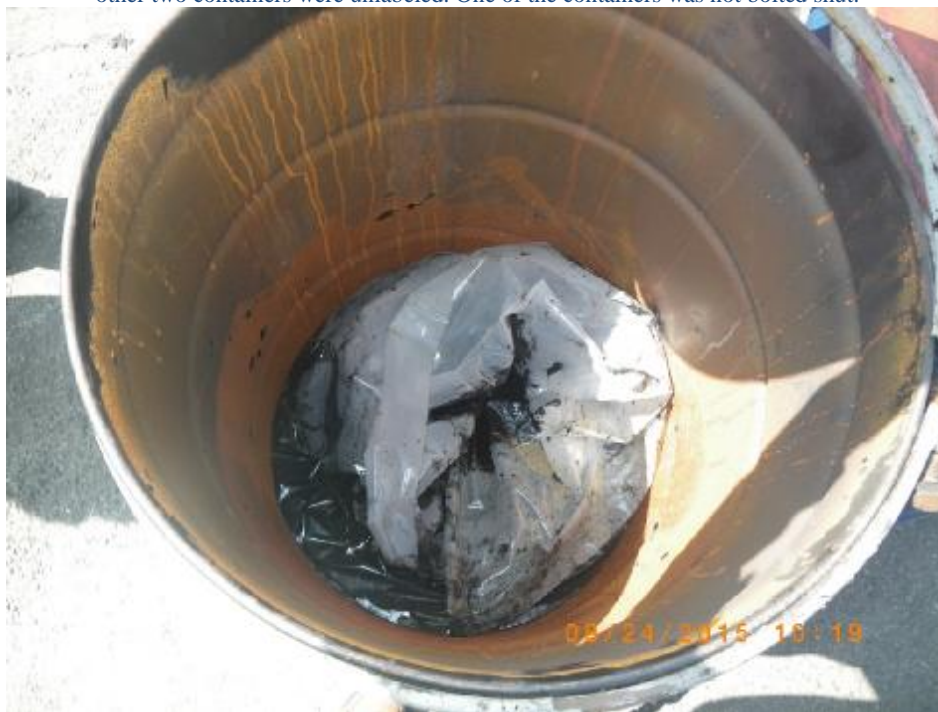
Photograph 6. IMG0185.jpg – Contents in one of the unlabeled containers shown in IMG0186.

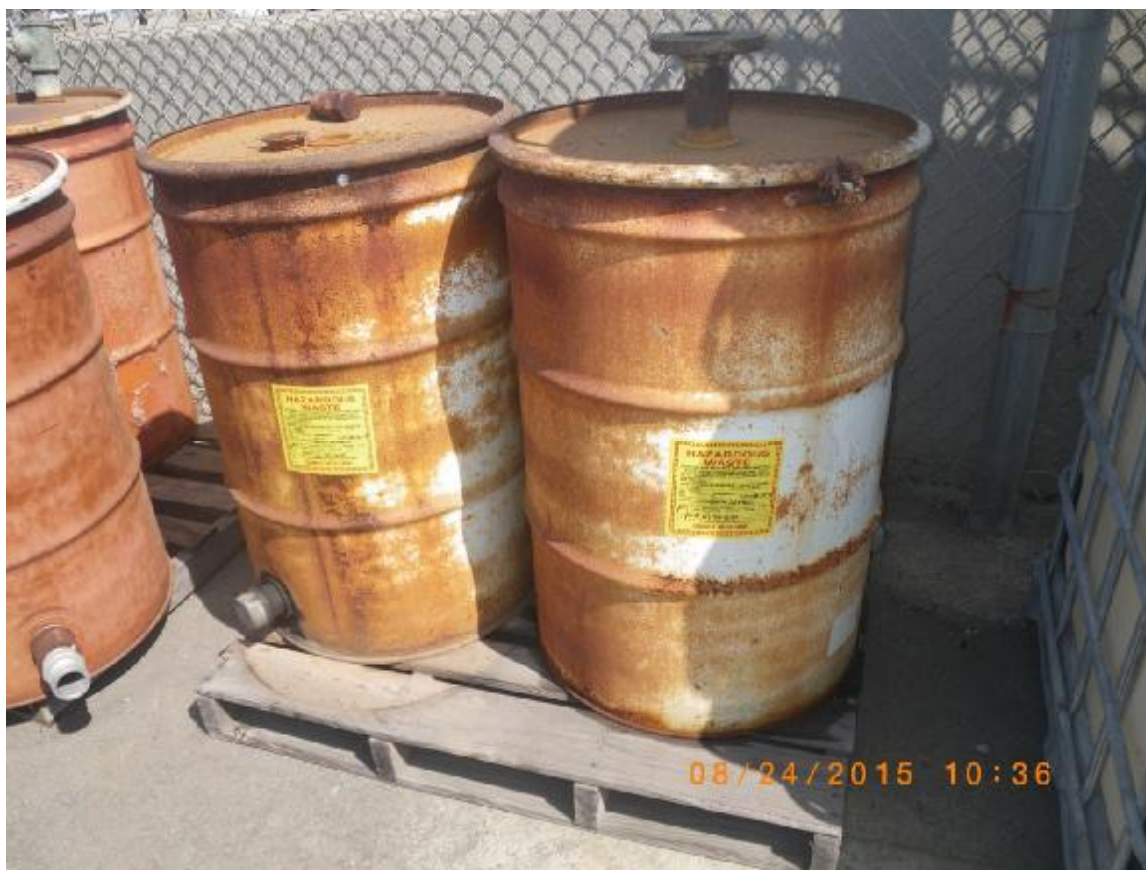
Photograph 7. IMGP0190.jpg – Two containers with hazardous waste labels for “Spent Carbon (O.R.U.) Tk-1620. The containers were not labeled when inspectors arrived (see IMGP0189).

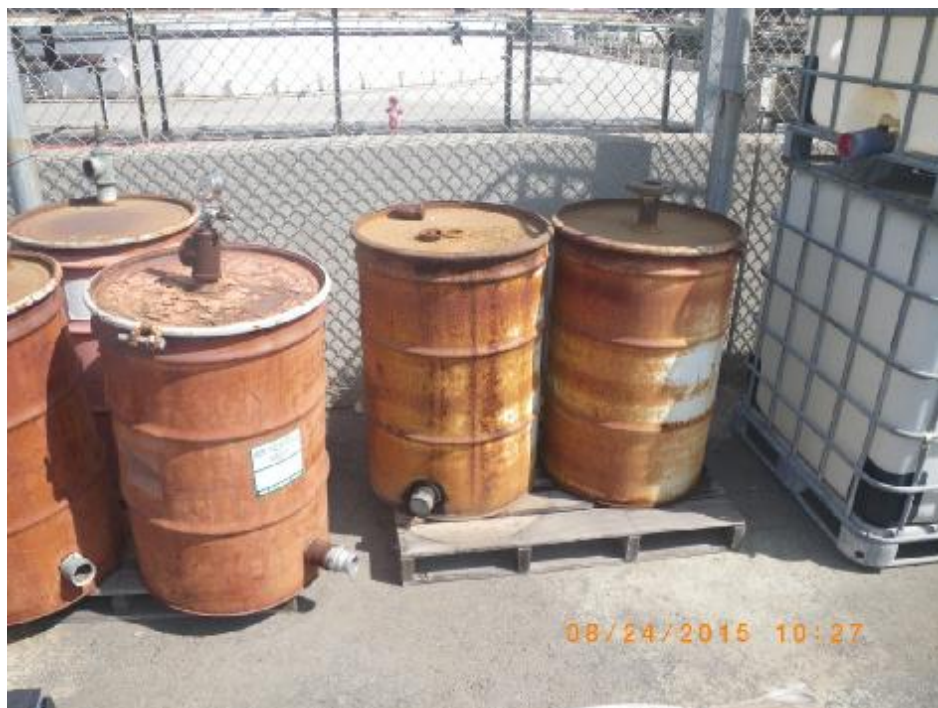
Photograph 8. IMGP0189.jpg – Unlabeled containers shown in IMGP0189. Staining beneath the container on the right indicates that the container was leaking.

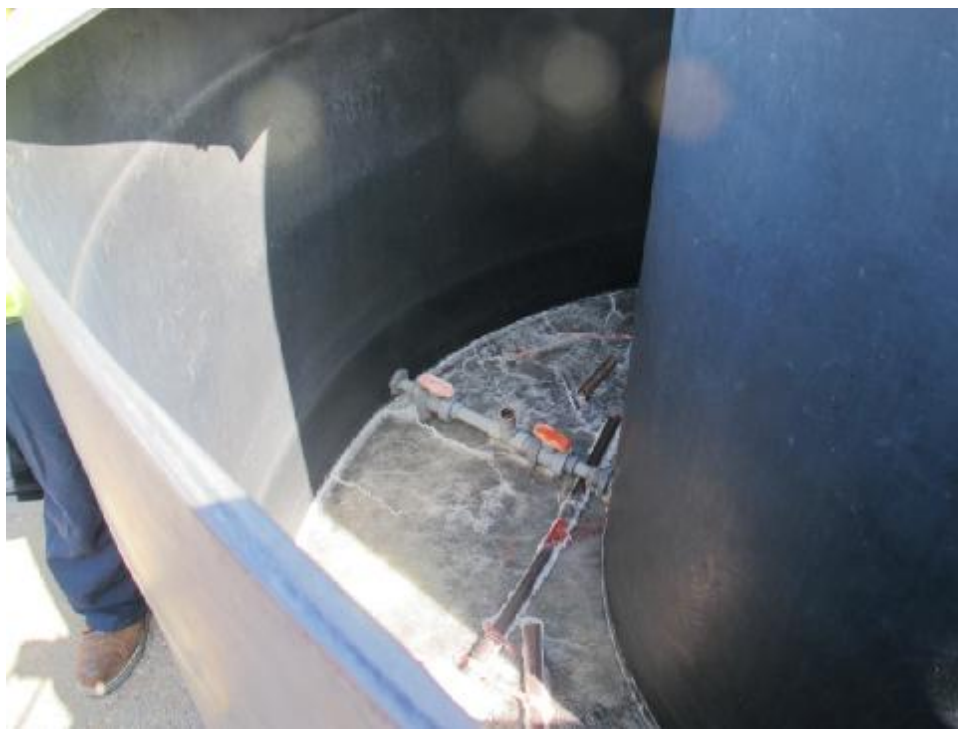
Photograph 9. IMG_0029.jpg – Accumulated crystallized sodium hypochlorite within a secondary containment system structure at the Carson HWAA.

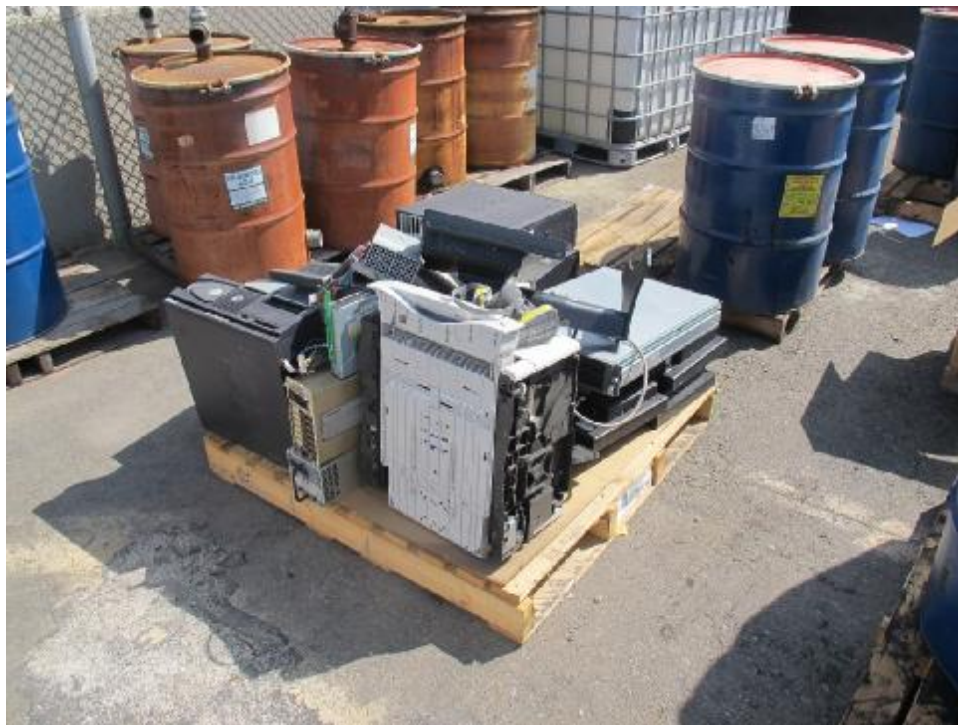
Photograph 10. IMG_0025 – Unlabeled and undated pallet of universal waste at the Carson HWAA.

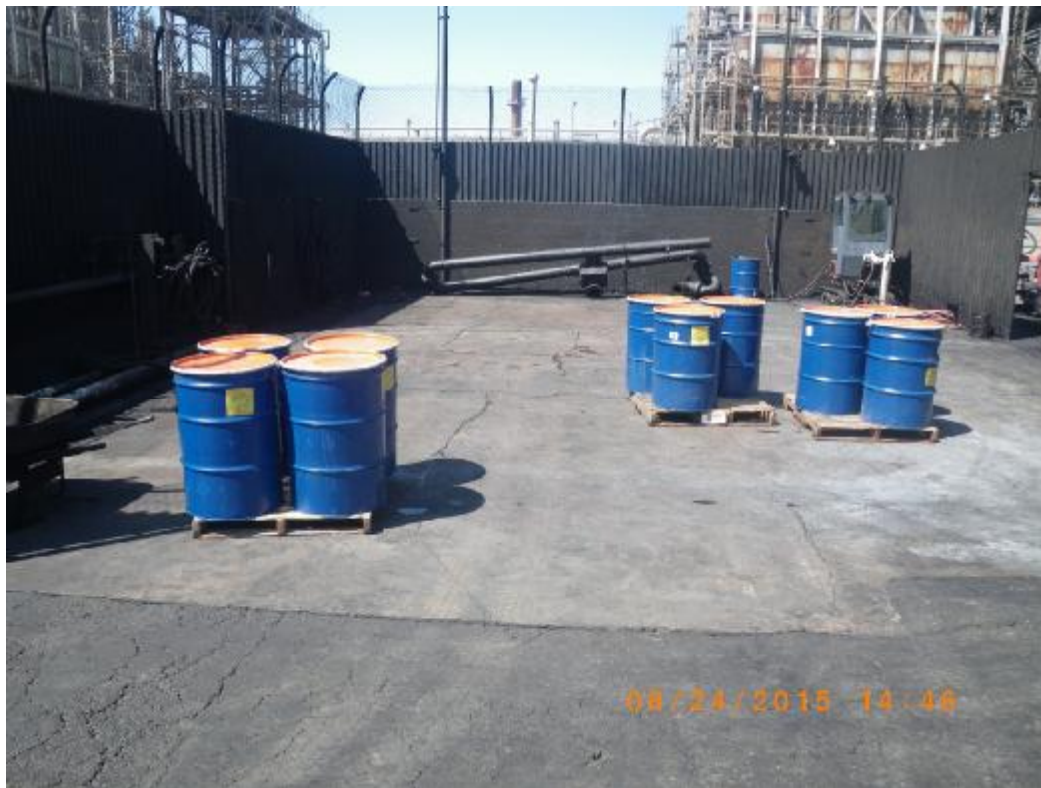
Photograph 11. IMG0232.jpg – Containerized hazardous waste that had previously been accumulated at the Carson HEB cleaning pad. Note the cracks on the surface of the HEB cleaning pad.

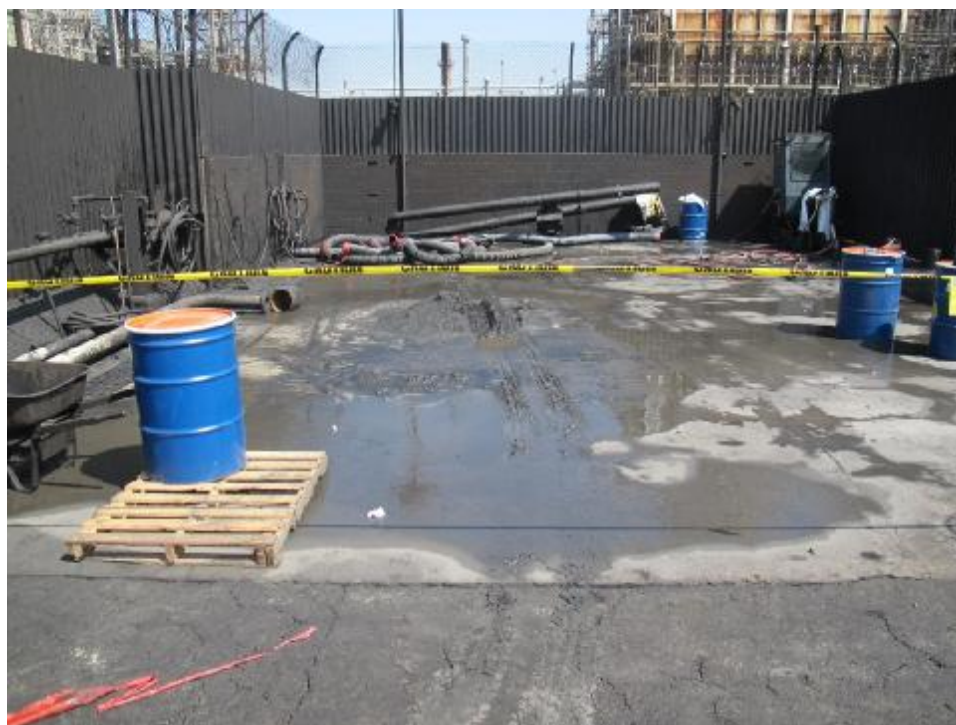
Photograph 12. IMG_0038.jpg – Waste piles at the Carson HEB cleaning pad. Note the tire marking in the waste piles and the drag-out of waste exiting the pad. Note: additional photos of the waste piles and the condition of the pad are available in IMG_0035 to IMG_0055.

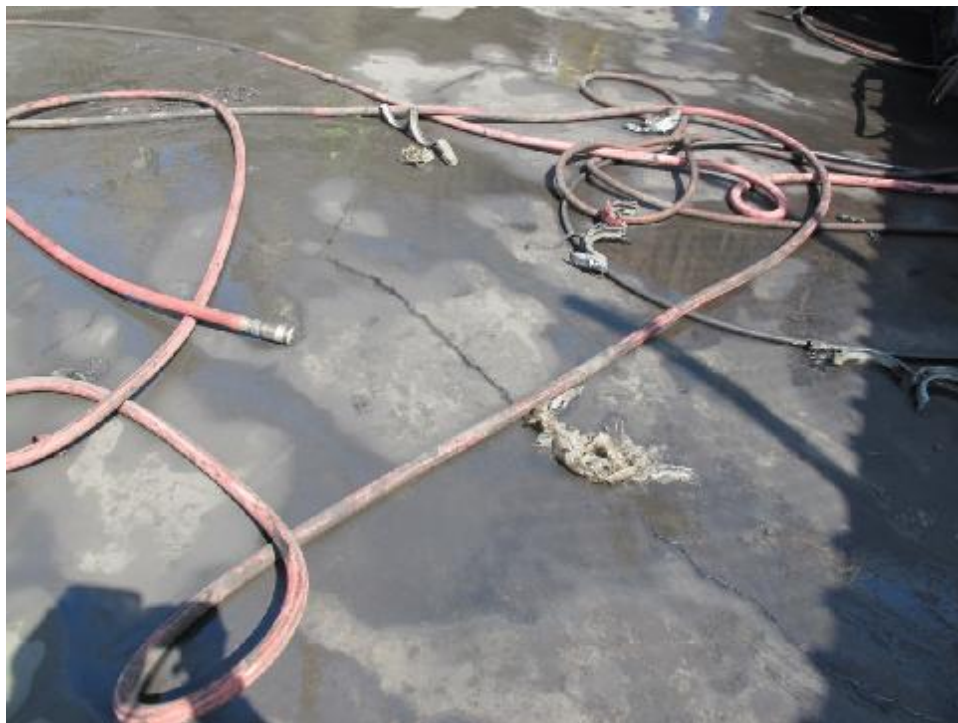
Photograph 13. IMGP0047.jpg – Visible cracks on the surface of the Carson HEB cleaning pad. Note: additional photos of cracks on the surface of the pad are available in IMG_0043 and IMG_0047.

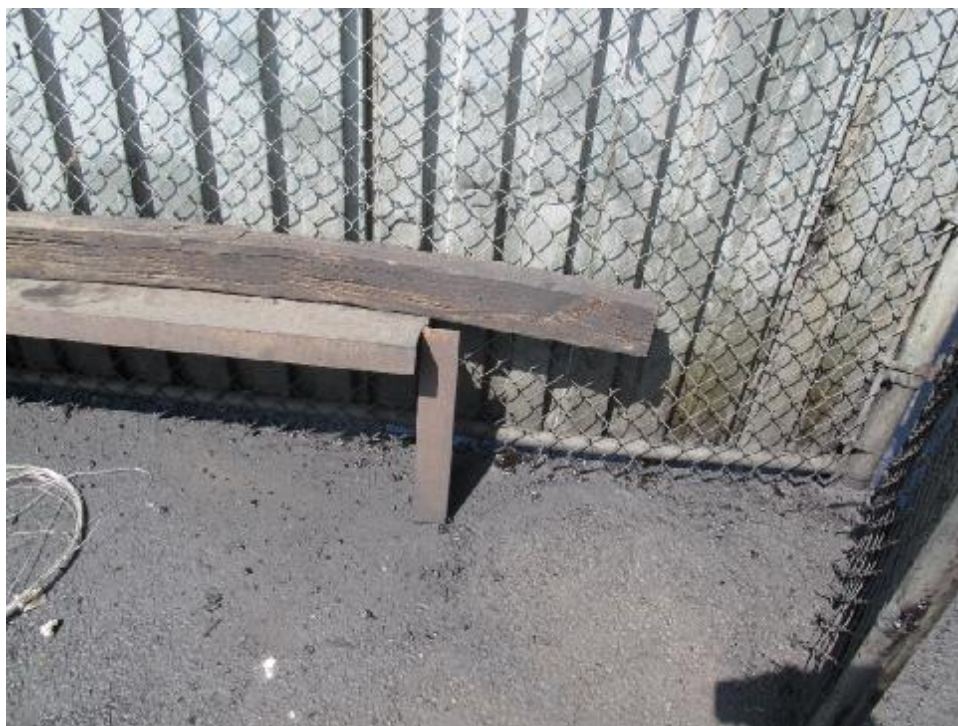
Photograph 14. IMGP0050.jpg – Photo taken from the outside of the HEB cleaning pad. Note the gap between the corrugated metal walls, allowing waste pile material to exit the cleaning pad. Additional photos of the gap can be seen in IMG_0046 and IMG_0049.

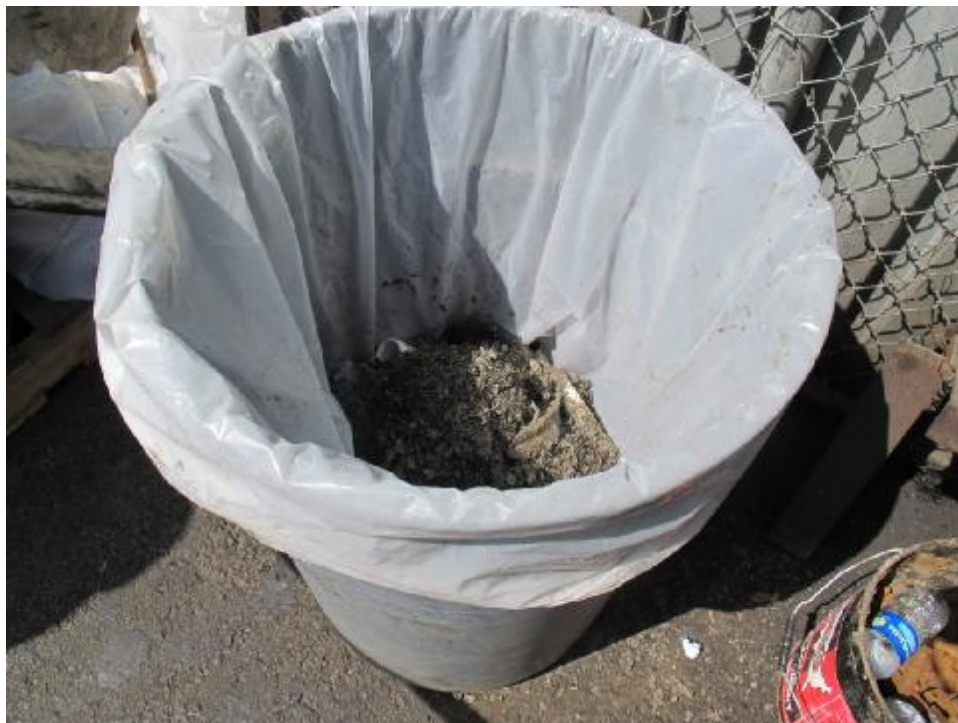
Photograph 15. IMG_0052.jpg - 30 gallon garbage container located outside of the HEB cleaning pad. Inspectors observed a dark gray material in this trash can which closely resembled the waste pile materials inside the HEB cleaning pad.

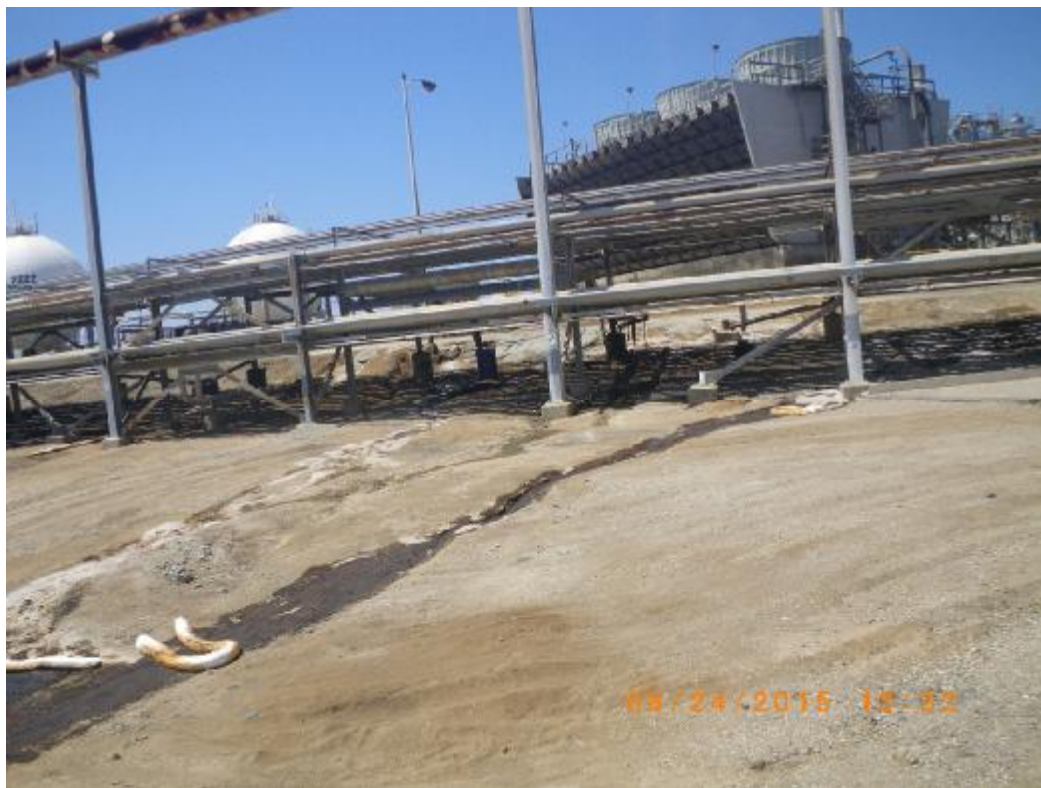
Photograph 16. IMG0218.jpg – Leaking black liquid draining into the Sump Area Flare area, located north of TK-12 and east of Flare SA-6. LARC personnel believed the leaking liquid was cutting oil used to clean a pipe. Several oil absorbent waddles and absorbant material indicate that the leak was ongoing.

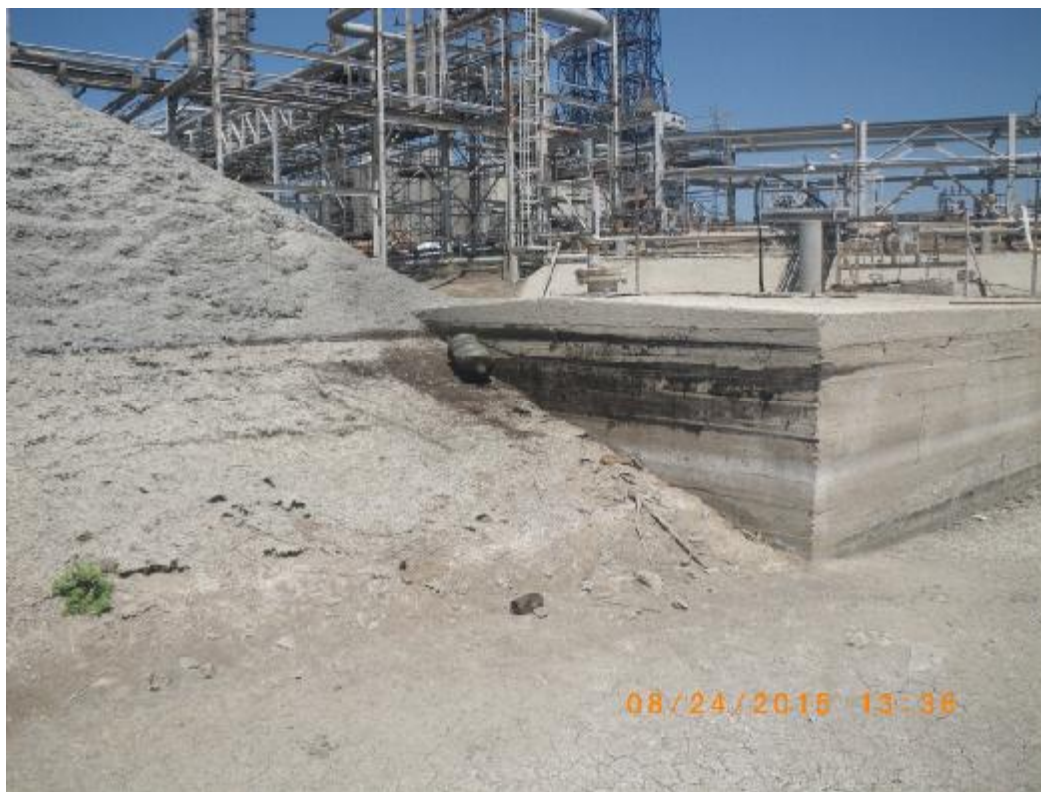
Photograph 17. IMG0224.jpg – Oily staining on the banks and surfaces of the Sump Area Flares pond. The staining indicates that liquids with hydrocarbons were stored in this unlined surface impoundment.

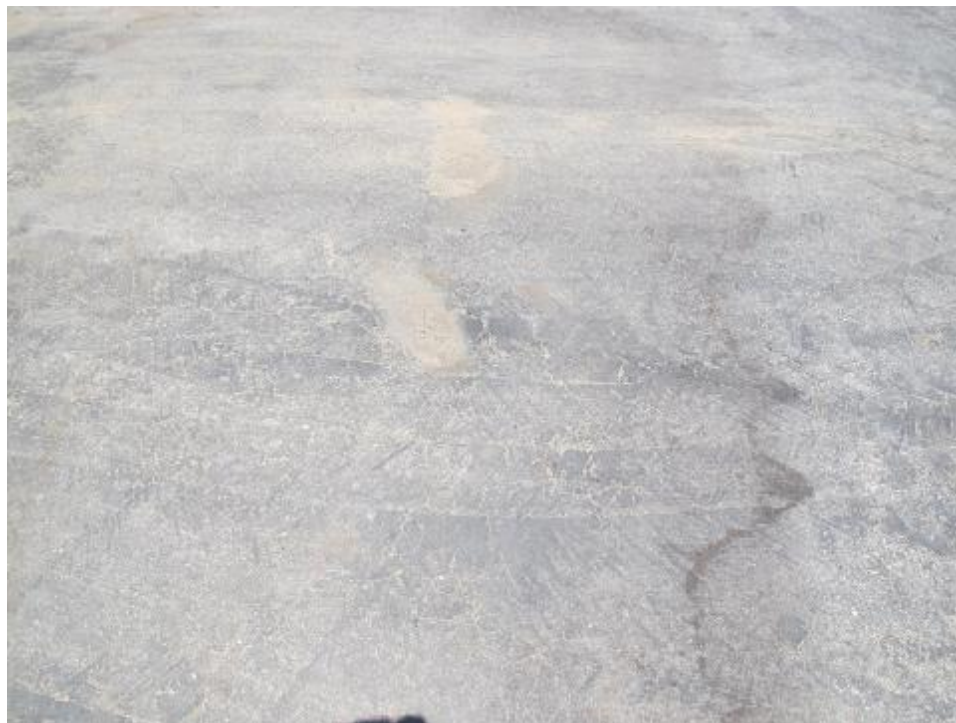
Photograph 18. IMG_0060.jpg – Cracks and gouges on the asphalt surface of the permitted former Process Water Pond. Note the accumulation of sediment on the surface in the upper center portion of the photo.

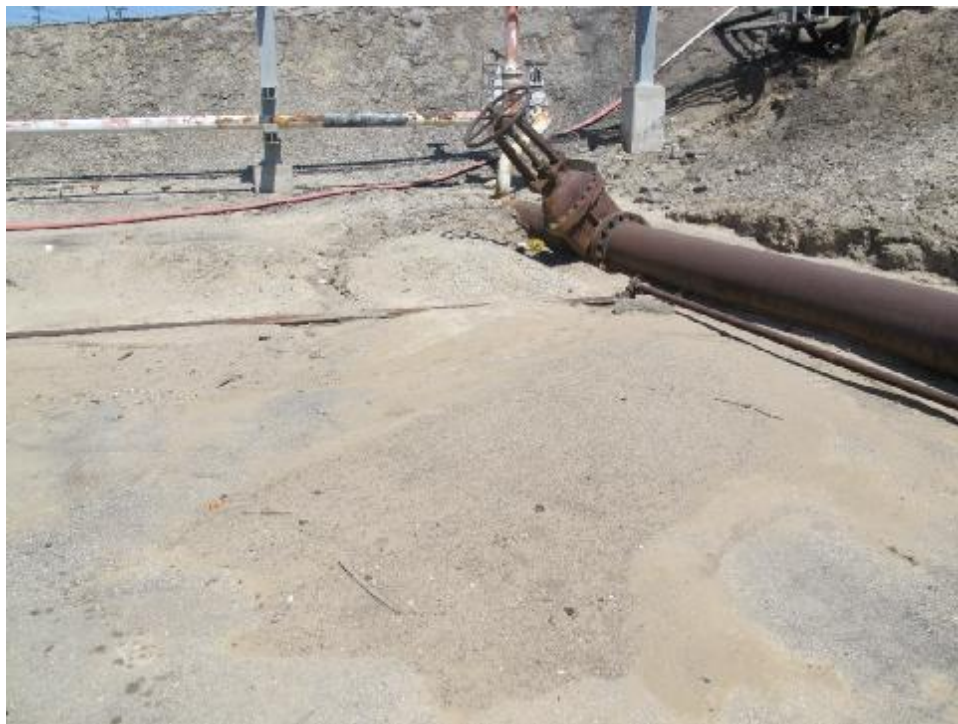
Photograph 19. IMG_0061.jpg – Unstabilized bank causing erosion onto the asphalt surface of the permitted former Process Water Pond.

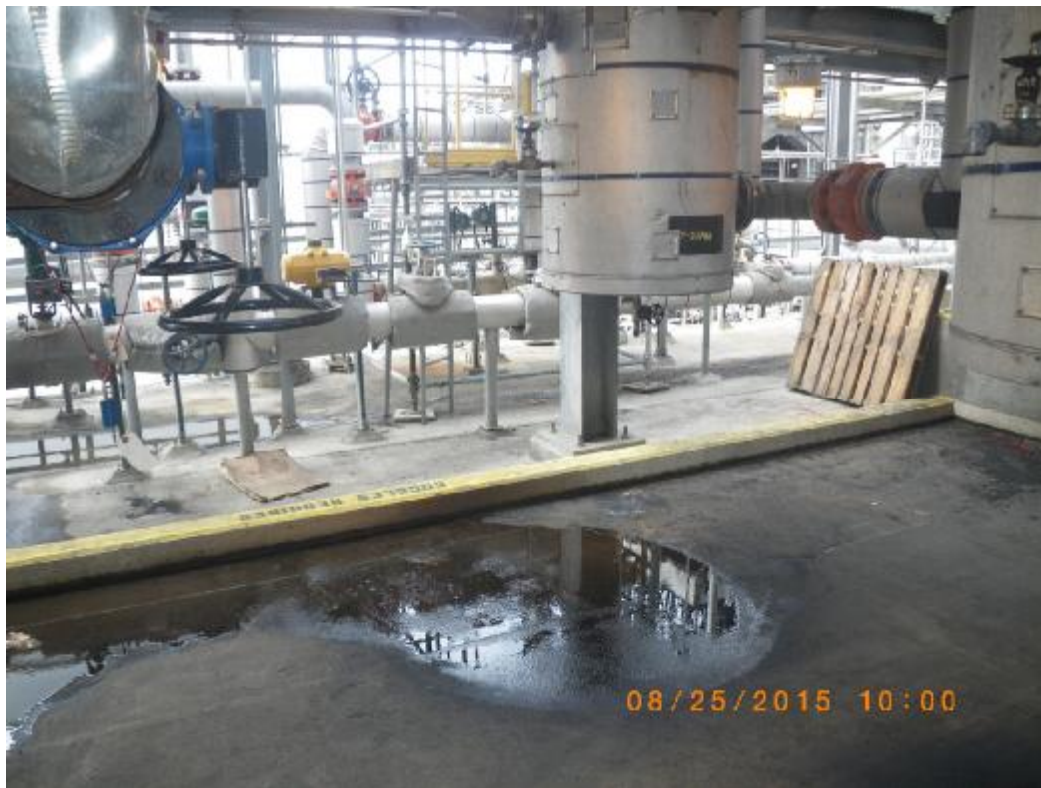
Photograph 20. IMGP0237.jpg – Stream of liquid coming from the Selenium Removal Unit, V-2370A. The liquid accumulated into a secondary containment berm, shown in IMG_0004, and discharged into a stormdrain shown in IMG_0006.

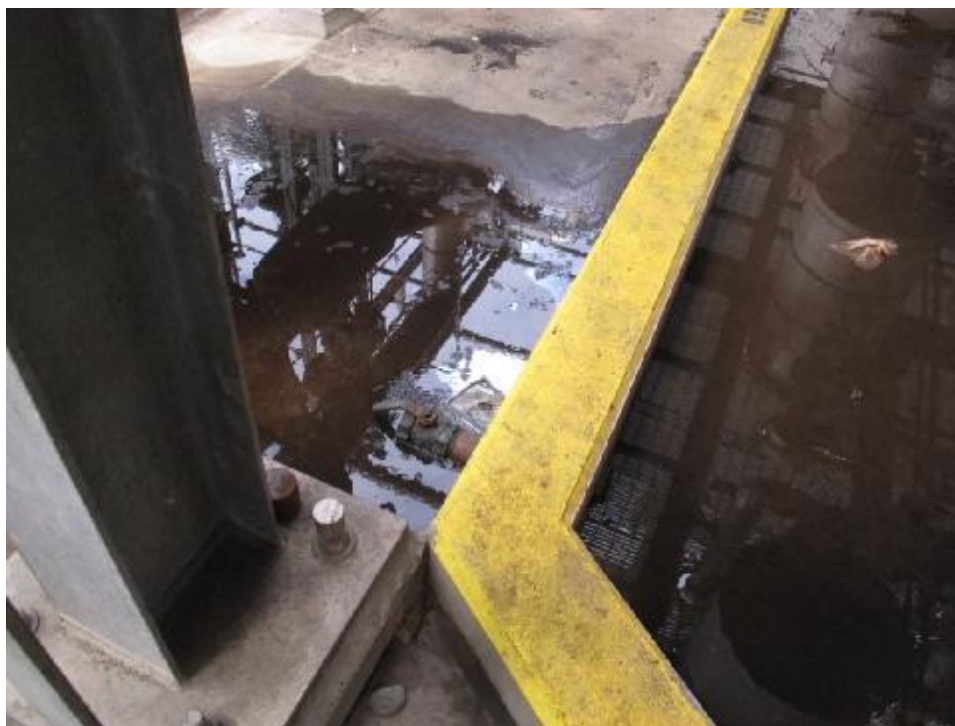
Photograph 21. IMG_0004.jpg – View of the concrete berm that partially contained some of liquid that drained from the Selenium Removal Unit, V-2370A.
